**TREE SURVEY,
ARBORICULTURAL IMPACT ASSESSMENT,
TREE PROTECTION PLAN &
ARBORICULTURAL METHOD STATEMENT
Rev:2,**

**Sunny Oaks Renewable Energy Park,
Whiterails Road, Wootton,**

Ridge Clean Energy Ltd.

Job no. MJC-22-0111

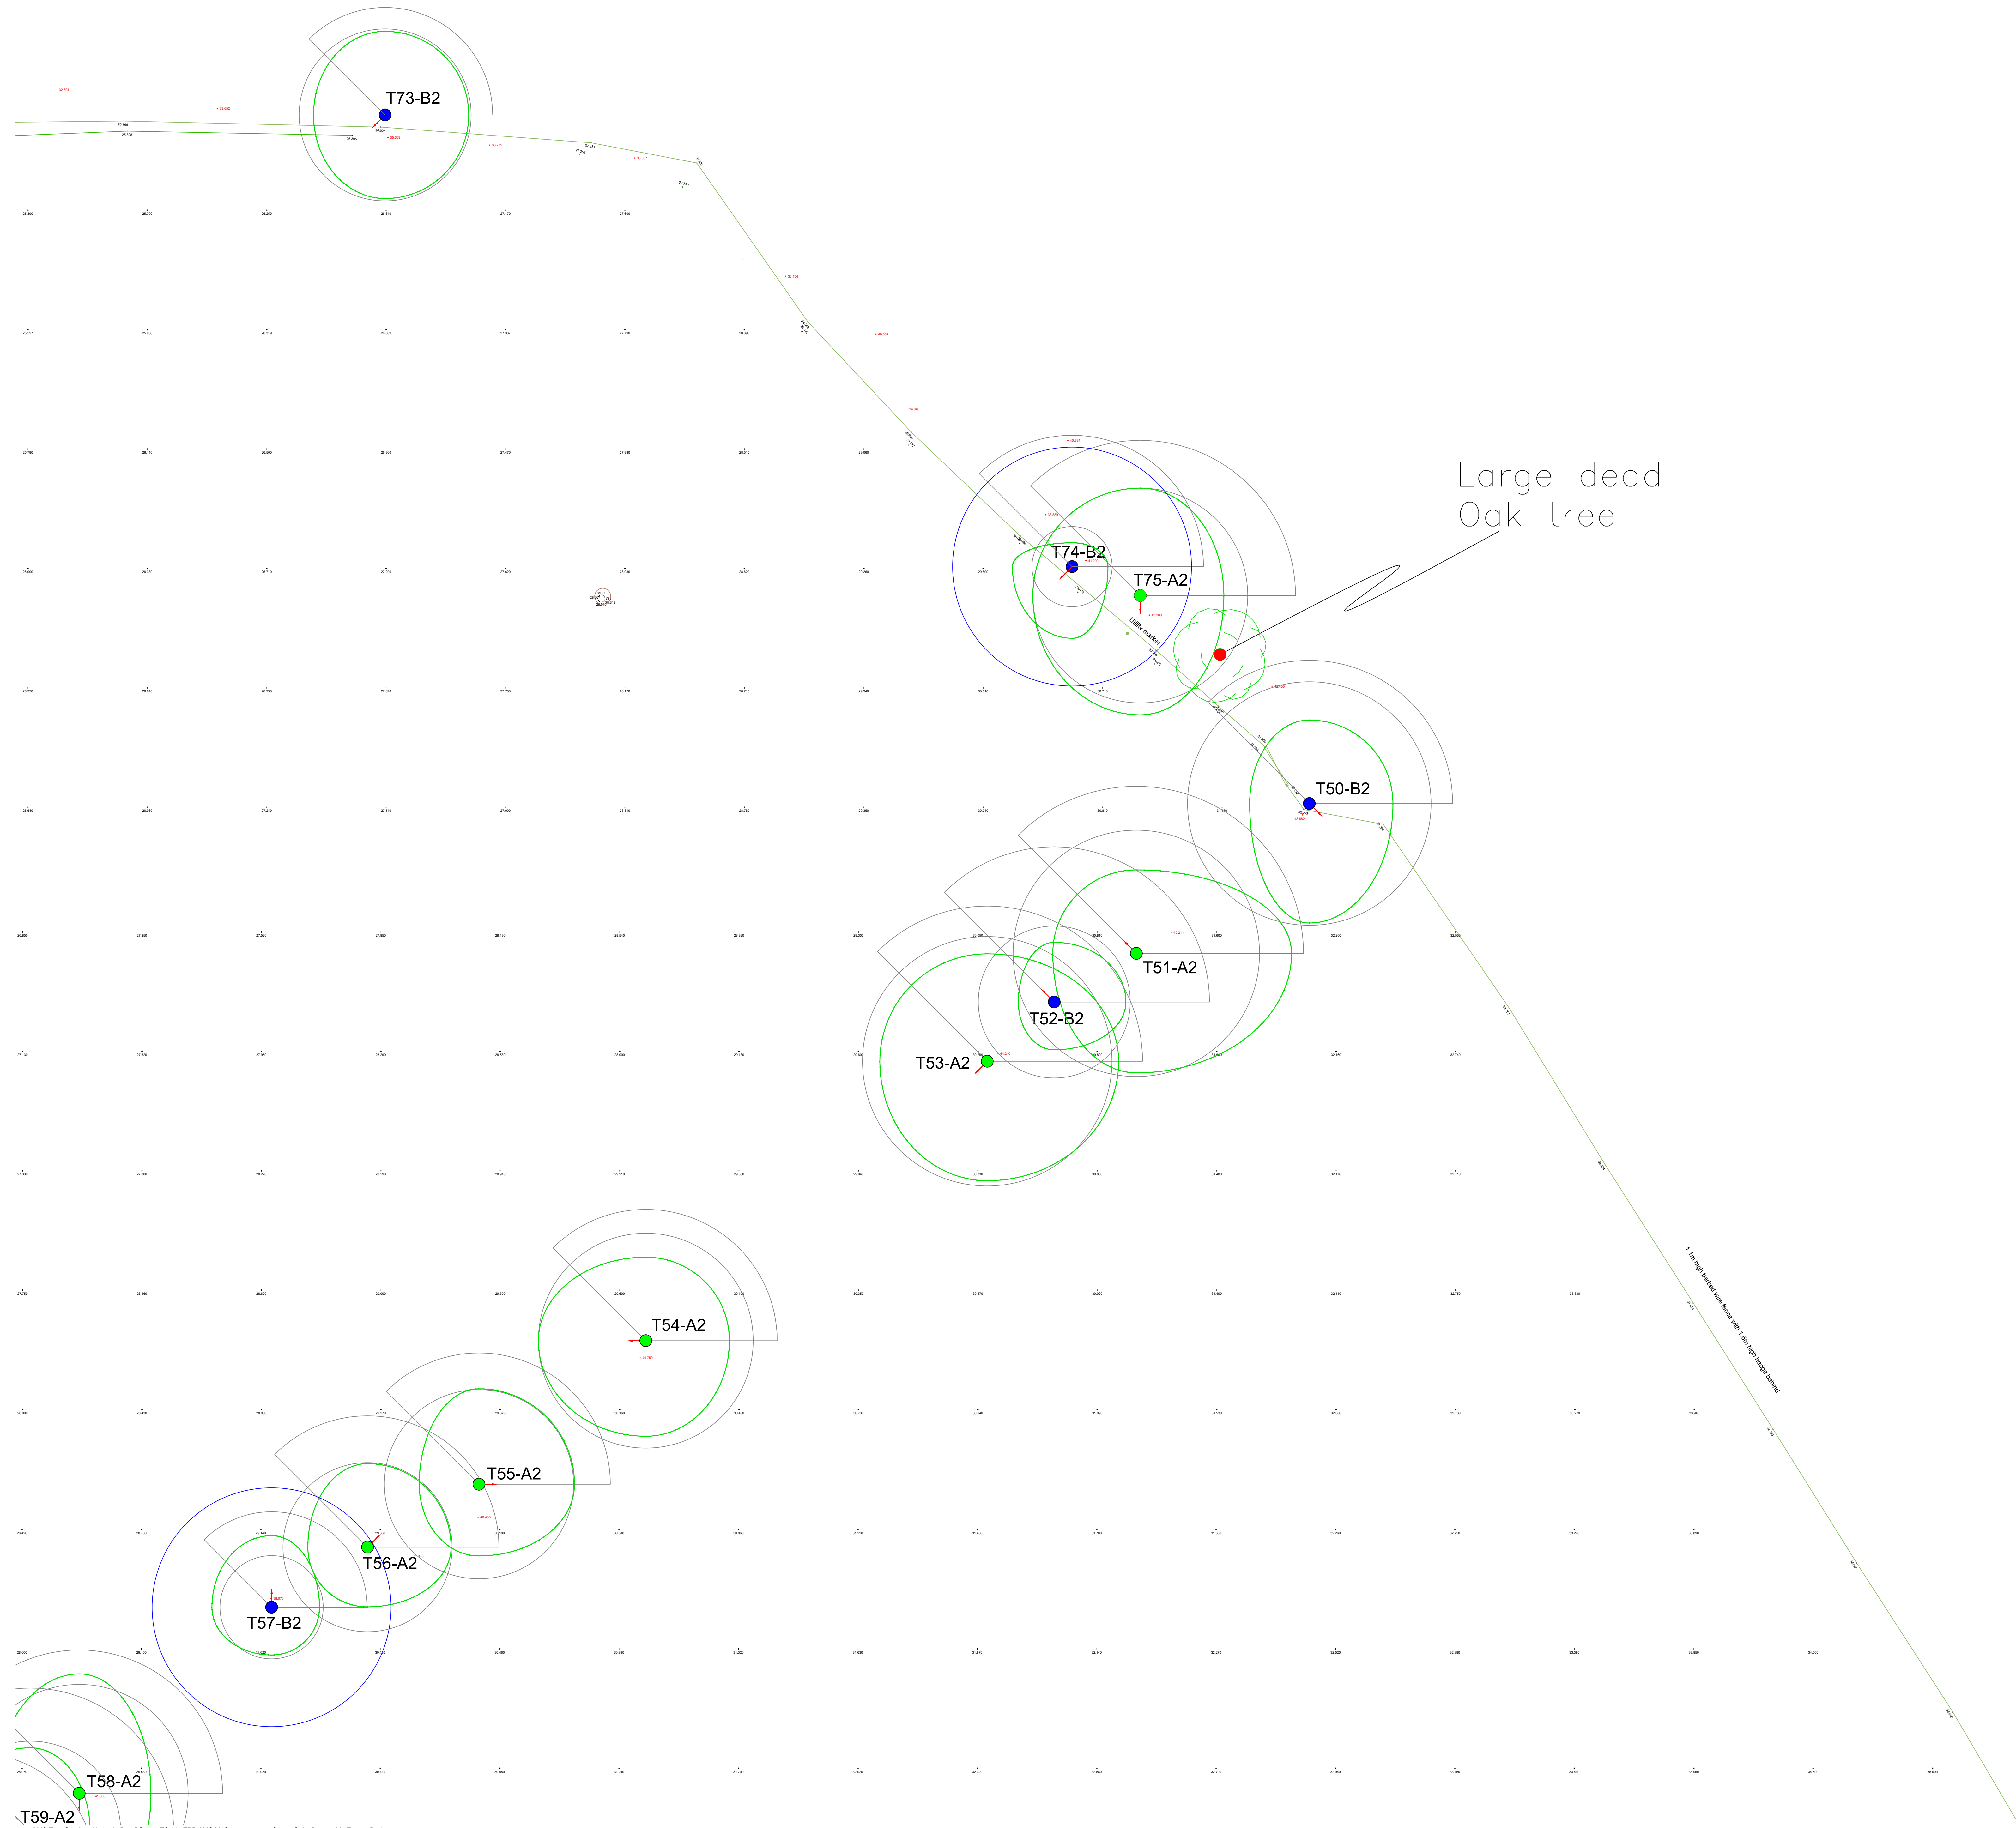
Large dead
Oak tree

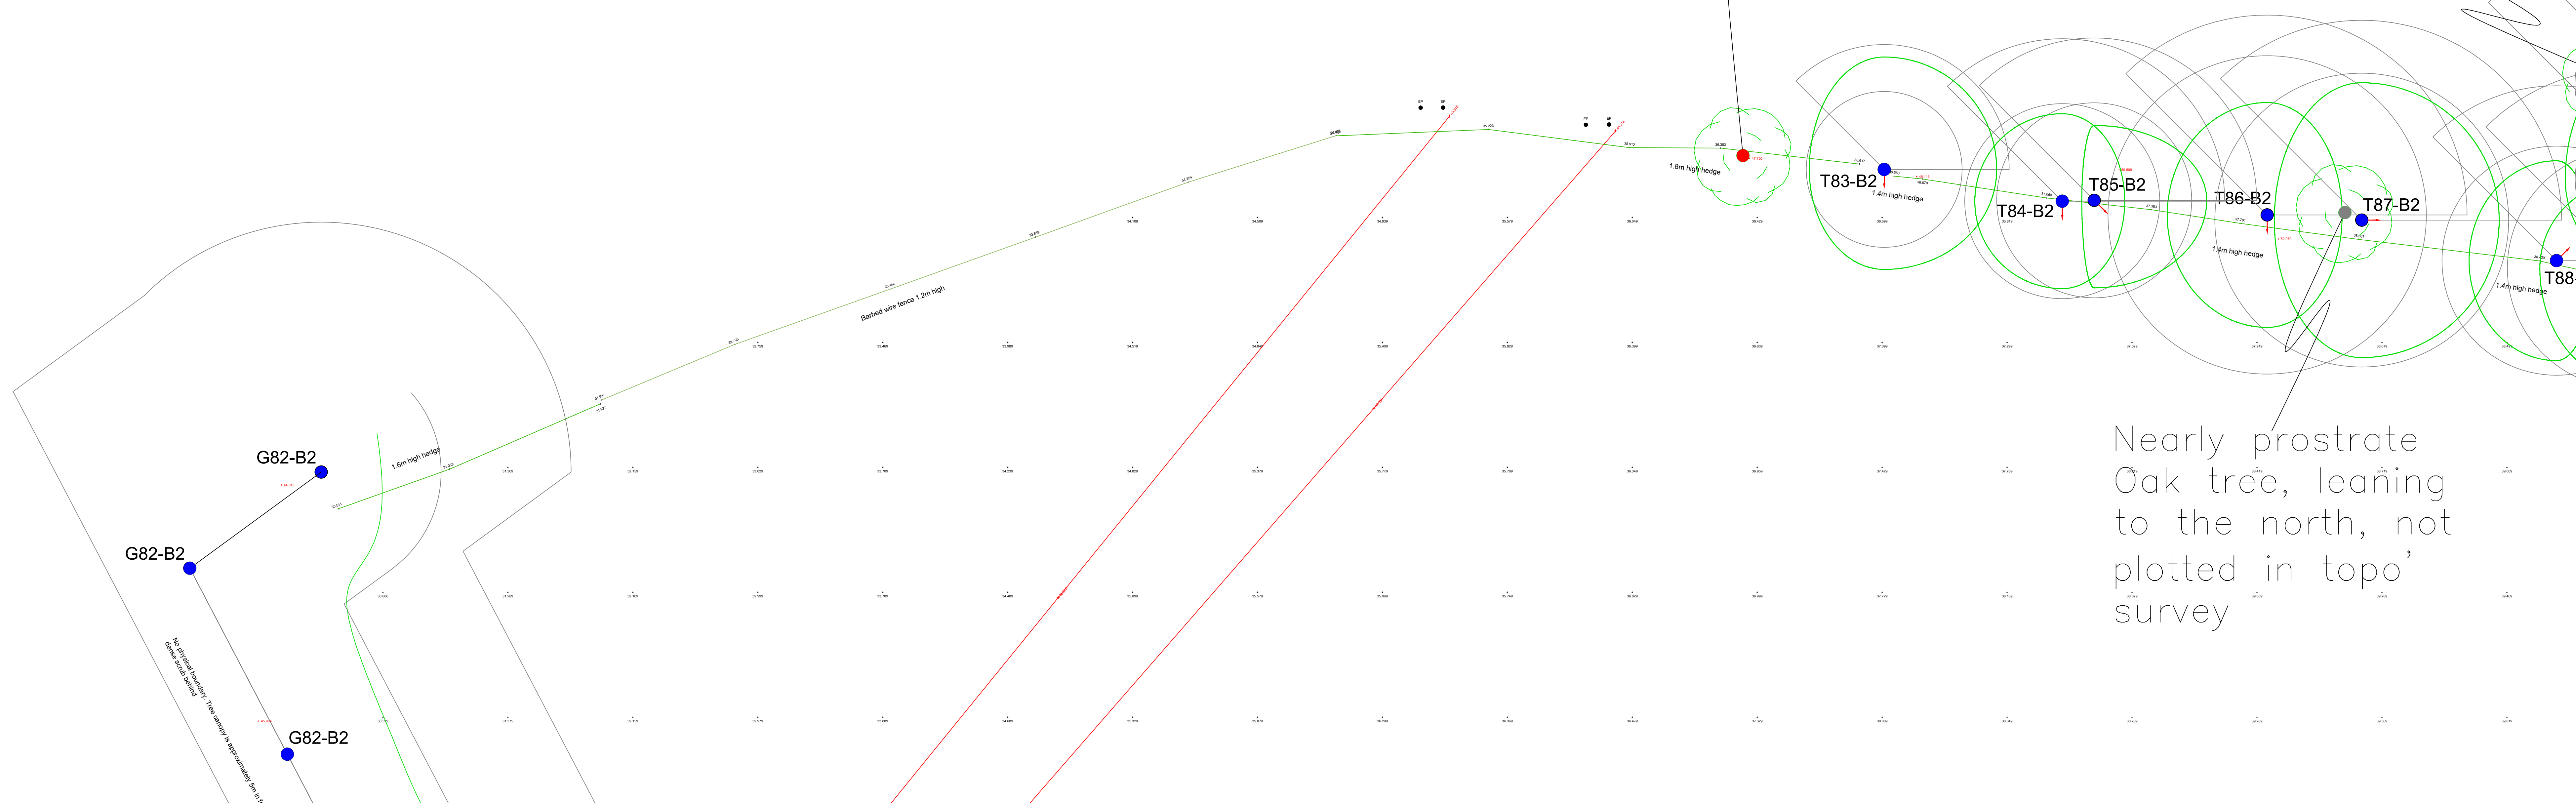
Standing dead Ash tree

Nearly prostrate Oak tree, leaning to the north, not plotted in topo' survey

standing dead
sh tree

prostrate
tree, leaning
north, not
in topo

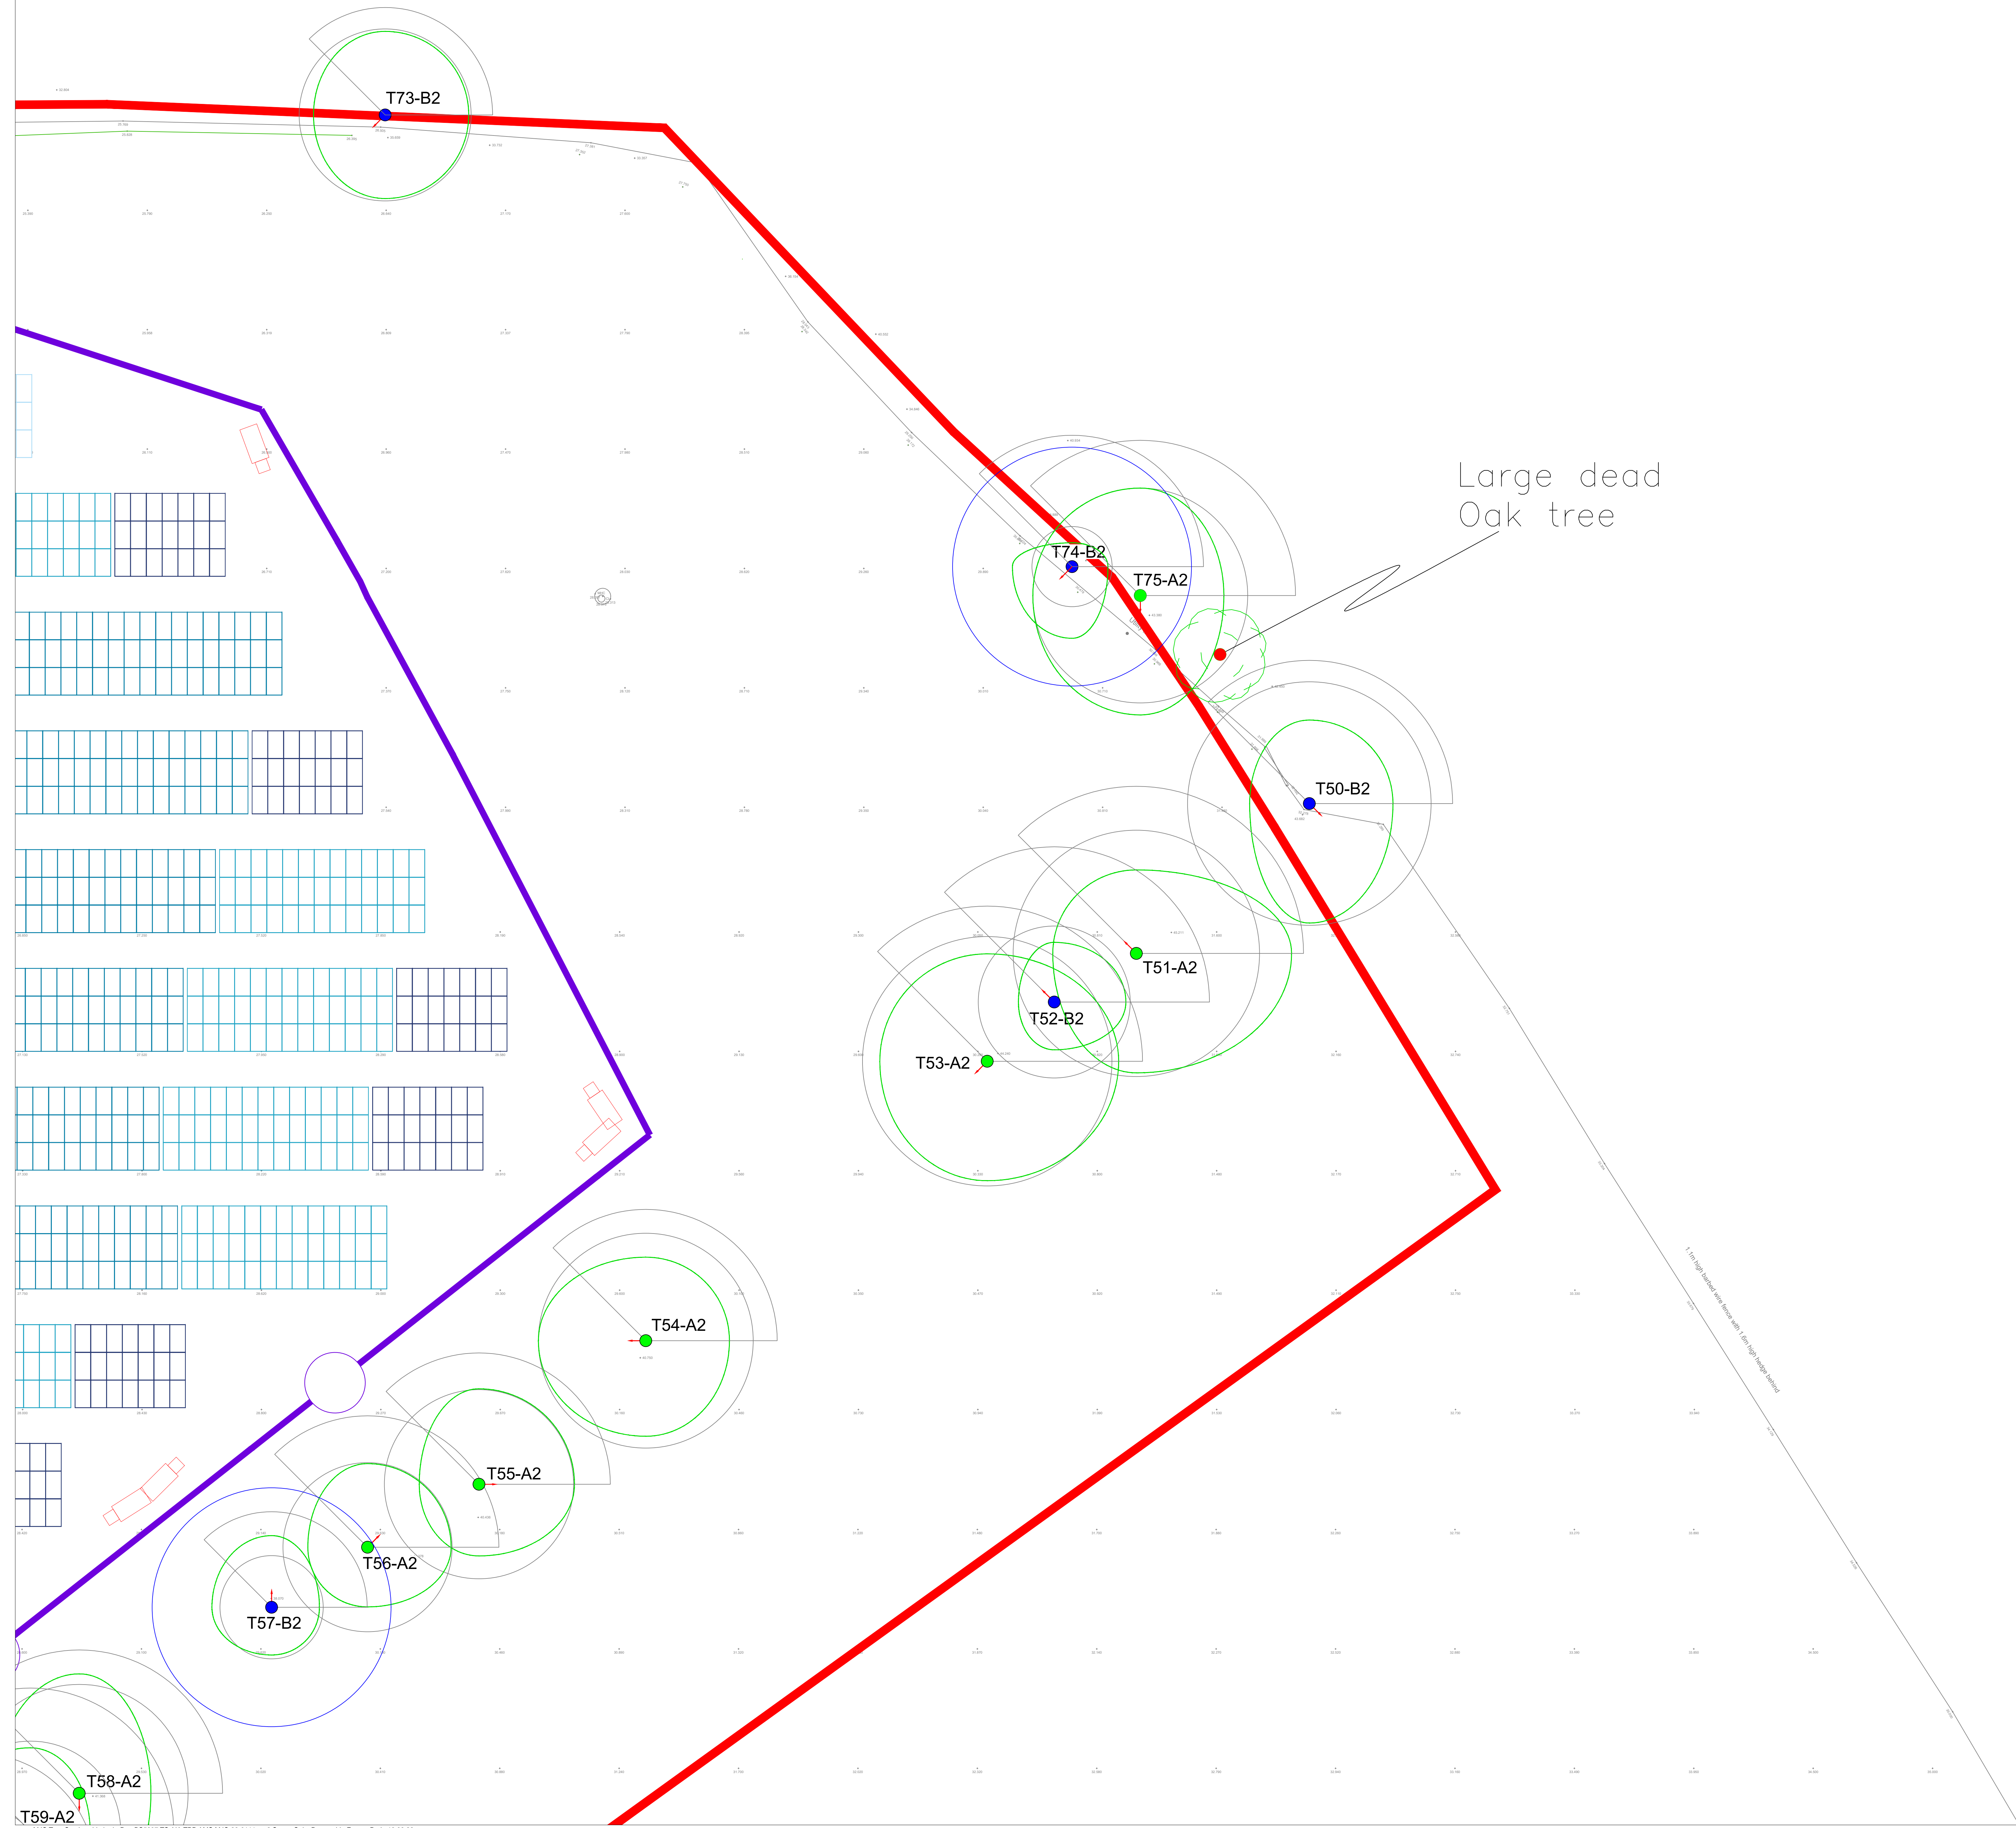
Large dead Oak tree

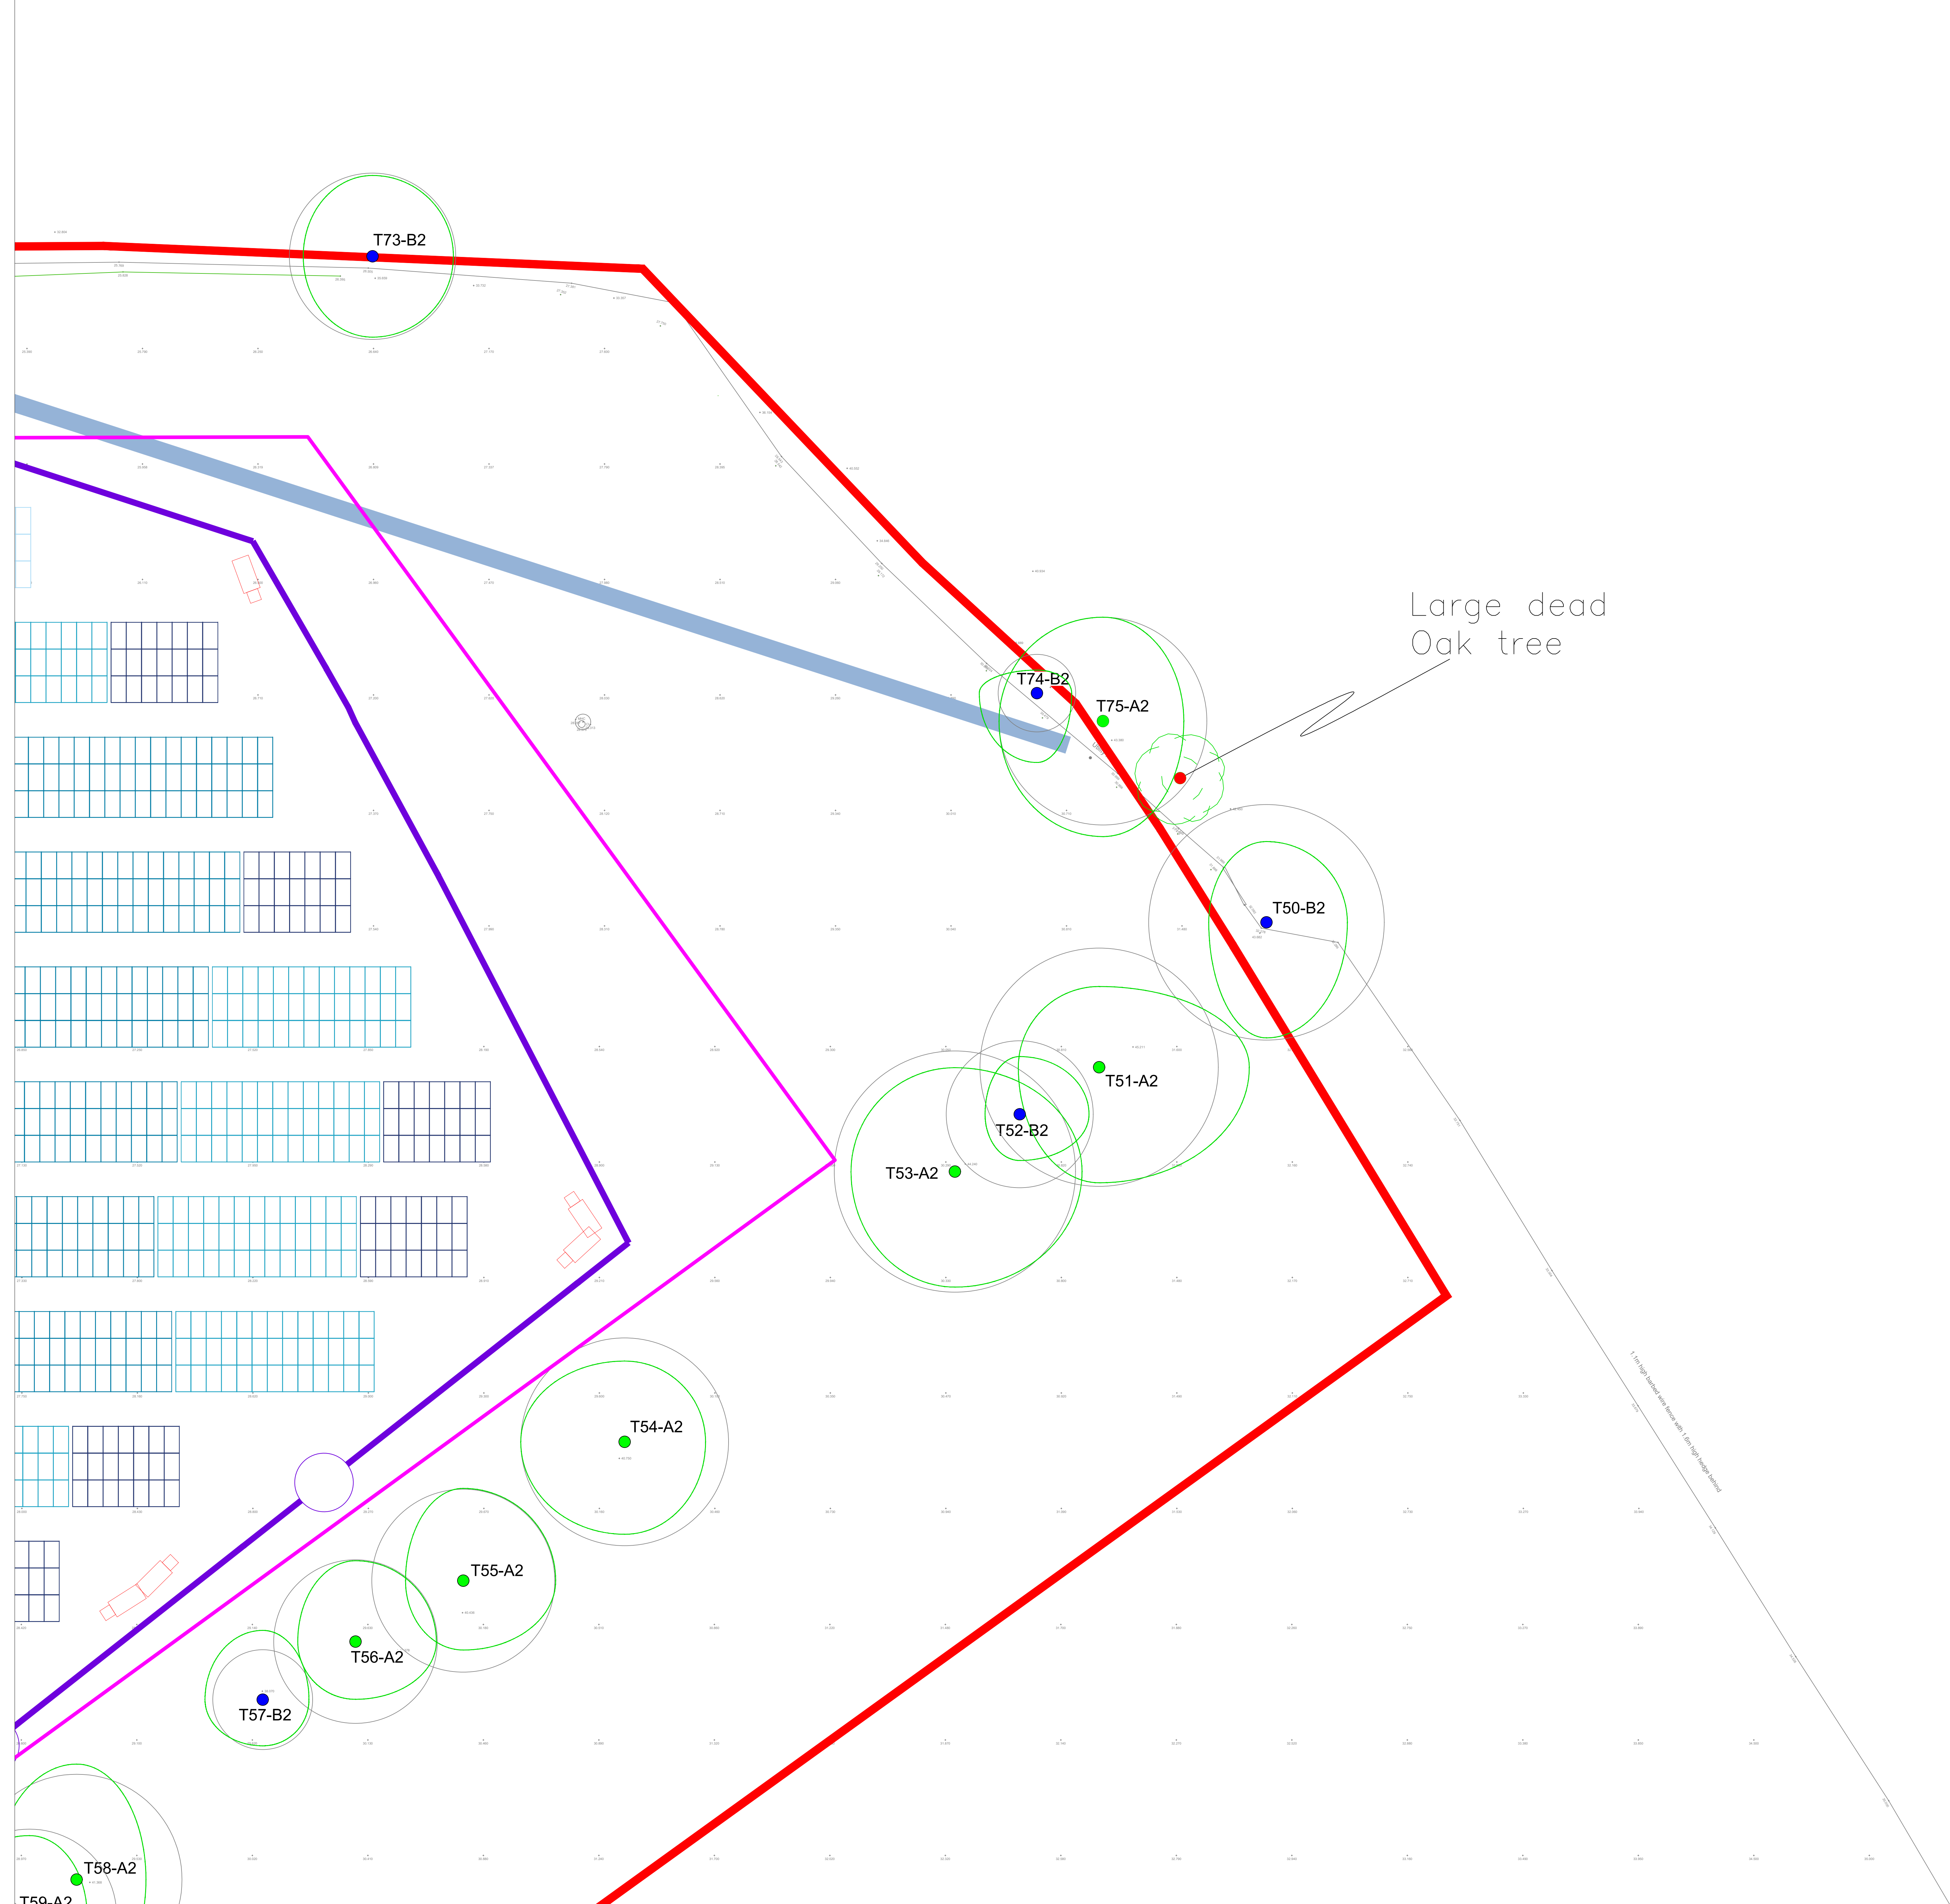
Large dead
Oak tree
